# ***Ebeye 2010 Infrastructure Survey Report***

565<sup>th</sup> EN DET (FEST-A)

15 June 2010

**SUBJECT: Ebeye Infrastructure Reconnaissance Report Closure Memorandum**

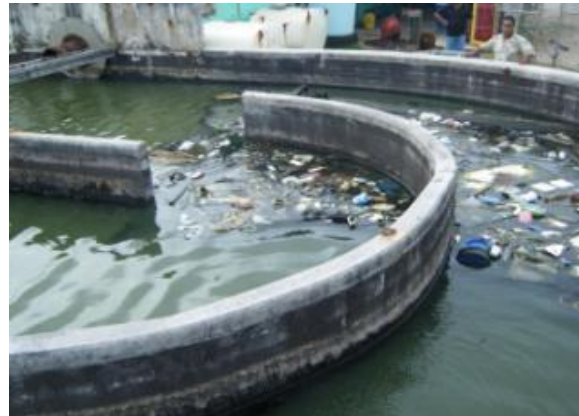
- a. The plant is no longer operable and would take considerable investment to bring to an operable condition. Many components have deteriorated or are missing. The oxidation ditch still exists and is no good shape. However, it is currently filled with trash and rainwater (Figure 2.5). The brush rotors are removed and corroding (Figure 2.6). The associated motors, mounts and seats are in need of repair or replacement (Figure 2.7). Overall the sewage treatment plant is in poor condition and could not operate if required. Figure 2.8 shows the current operation of the sewage treatment plant is in bypass.

**Figure 2.5-Debris and rainwater in the oxidation ditch**

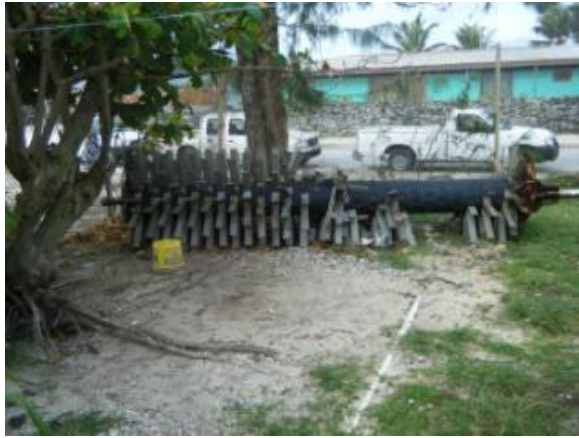
Figure 2.6 - Brush rotor removed and corroding

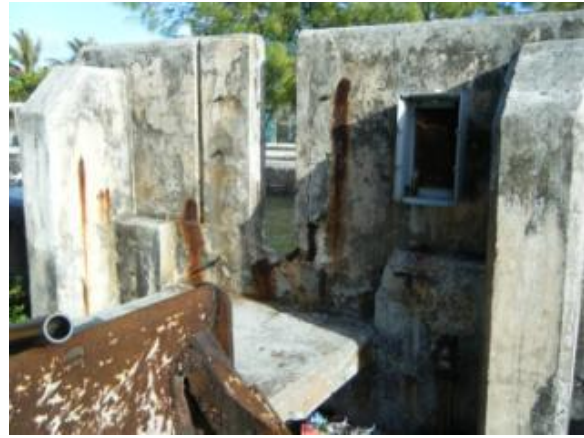
Figure 2.7 - Rotor seat empty and in need of repair

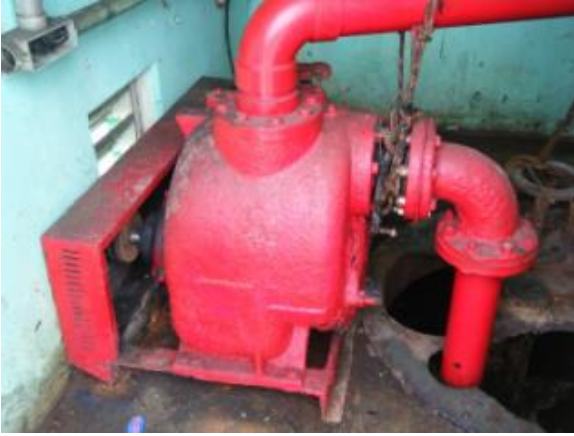
**Figure 2.10 - Lift station #3 is the only one with an original pump, but the backup is gone**

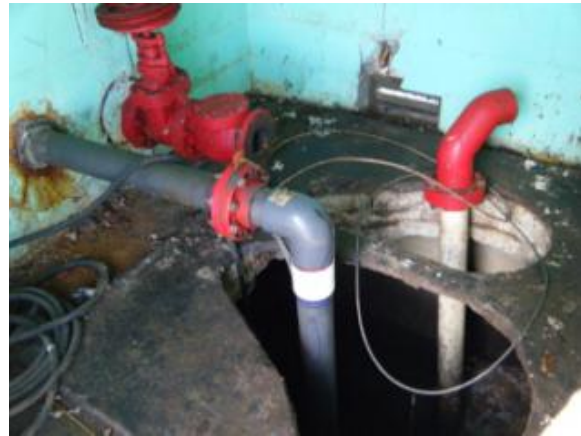
**Figure 2.11 – Lift station #2 original pump and backup are no longer there**

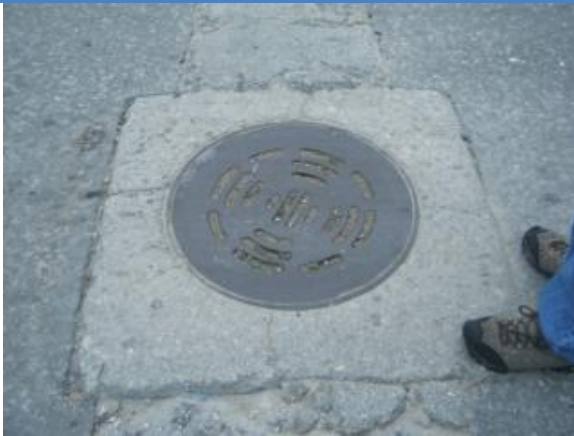
1. The inspected drywells on the island were clogged with dirt and no longer functioning (Figures 2.14 and 2.15). Additionally, most of the trench drains on Ebeye are also filled with debris and sand (Figures 2.16 and 2.17). These drainage structures cannot function if filled with sand. The sand made it impossible to inspect these drainage structures for physical defects. It is assumed most of these drainage structures are in good shape.

**Figure 2.14 - Dirt can be seen up to the cover of this drywell**

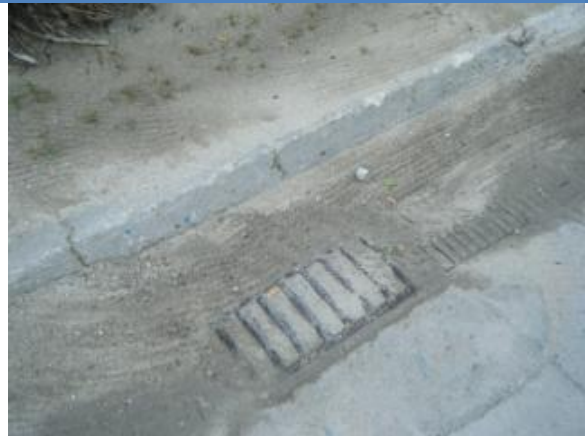
**Figure 2.15 - This side drain is filled with sand**

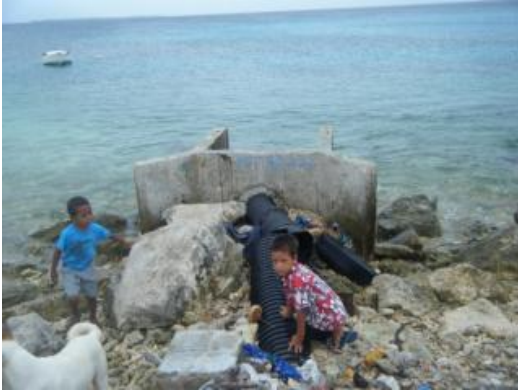
**Figure 2.18 - Outfall exposed due to erosion and damaged**

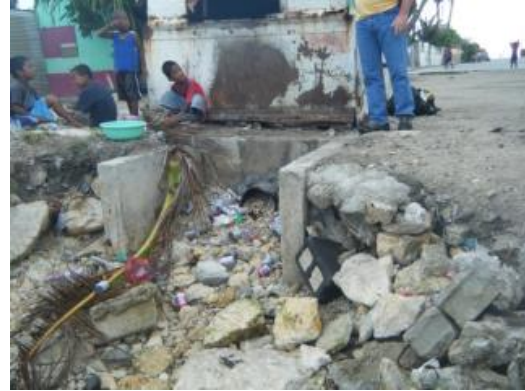
**Figure 2.19 - Outfall clogged with sand**

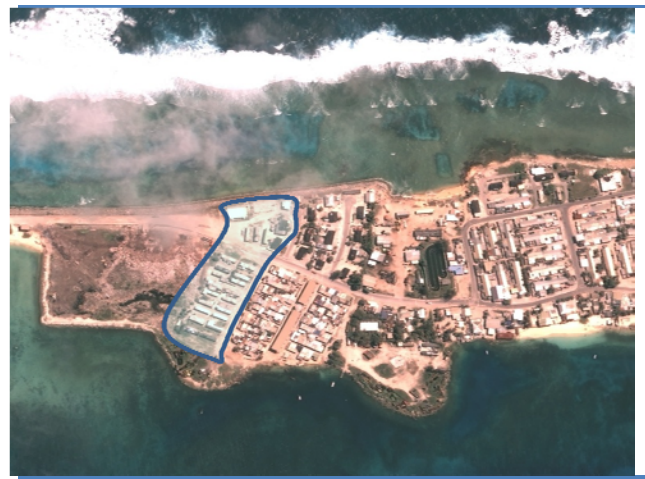
**Figure 3.10 - Area not covered by water distribution systems**

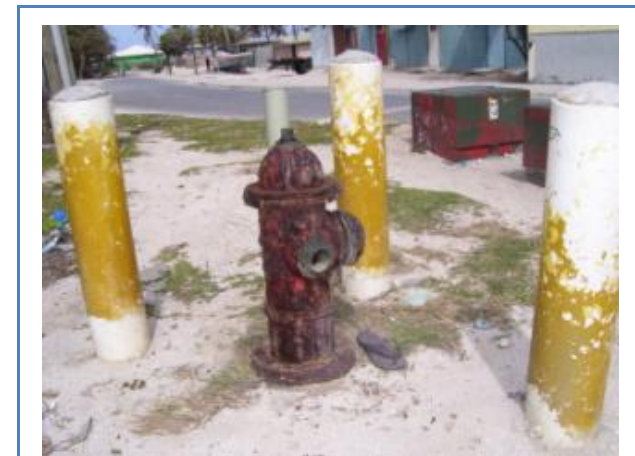
10. FW and SW distribution systems (pipes, valves, hydrants). During our visit there was no indication of leaks. Visual inspections of valves produced no significant adverse findings. Fire hydrants are in poor condition, heavily corroded, and are not being used (Figure 3.14).

**Figure 3.13 - Fire Hydrant Condition (typical)**

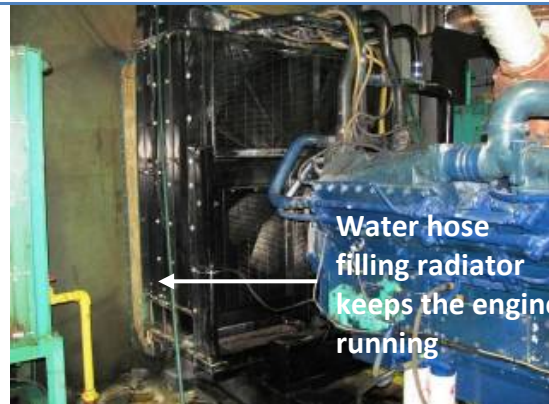
Figure 4.8 – Leaking Radiator - Unit #3

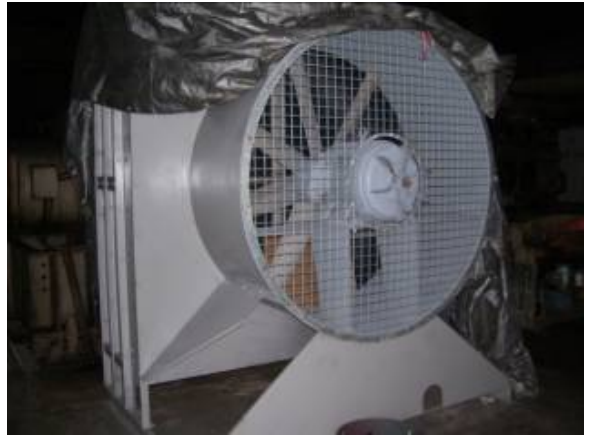
**Figure 4.28 – Replace Leaking Radiator on Generator #3**

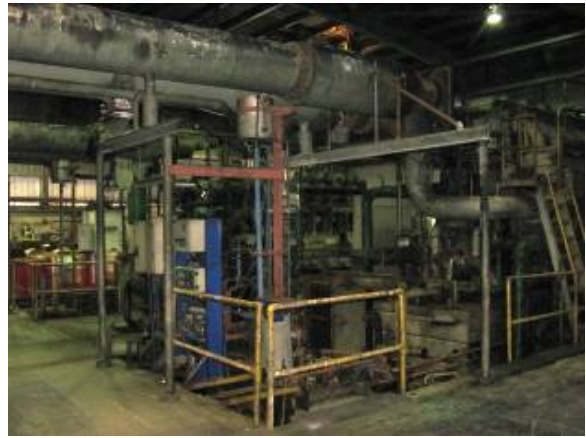
**Figure 4.29– Abandoned Enterprise Engines**

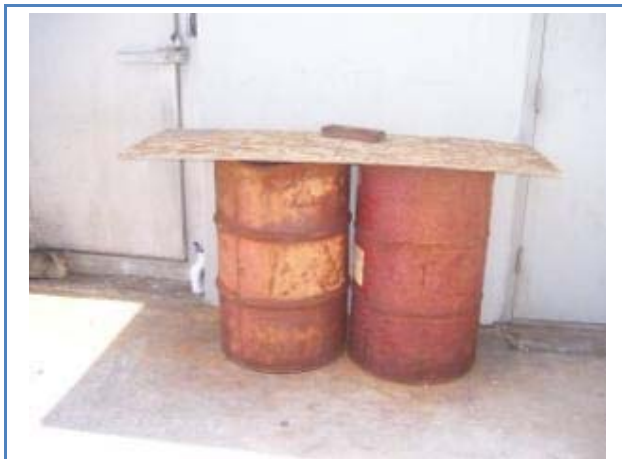
1. The five ton truck with dumpster attachment is in poor condition and occasionally breaks down due to heavy usage. Budget constraints and lack of availability make obtaining replacement parts difficult
2. Field observations indicate that approximately 50% (160) of the trash collection bins need to be replaced. Most are missing lids, wheels or are broken. The open and broken containers attract rats, flies, dogs and cats.
3. The medical waste generated at the hospital is stored next to regular trash in an uncovered non-secured area. The containers utilized are not appropriate for medical waste. The two drums that are used to accumulate the sharps and red bag waste are covered with a piece of plywood (Figure 5.4).

**Figure 5.1 - Medical waste accumulation point at the hospital**

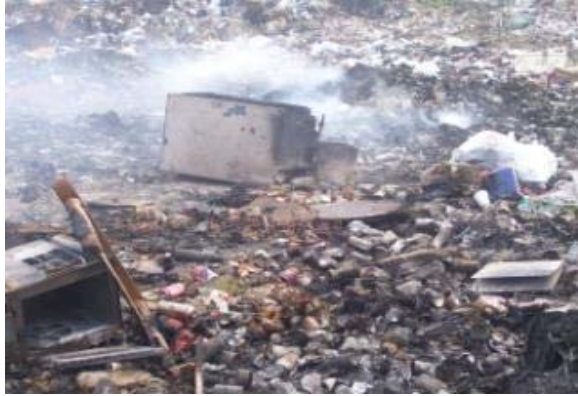
**Figure 5.3 - Open trash burning**

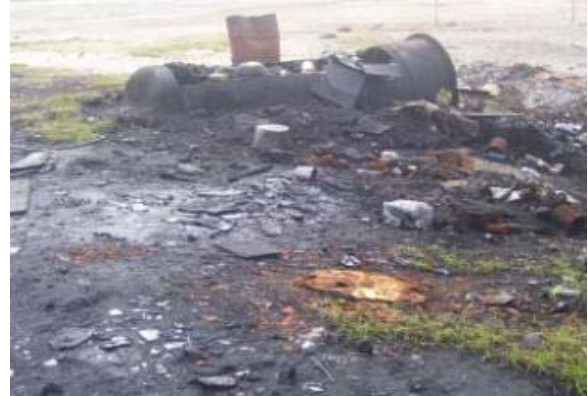
**Figure 5.4 - Waste oil dump and burn area**

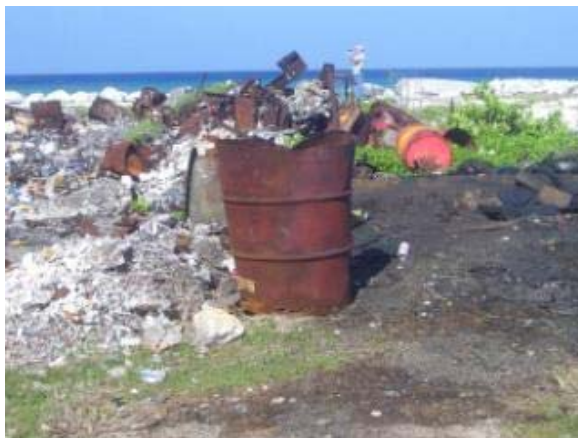
**Figure 5.5 - Medical waste burn barrel**

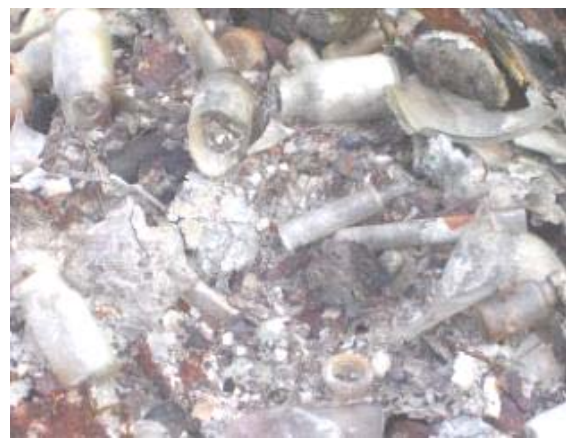
**Figure 5.6 - Partially burned medical waste**

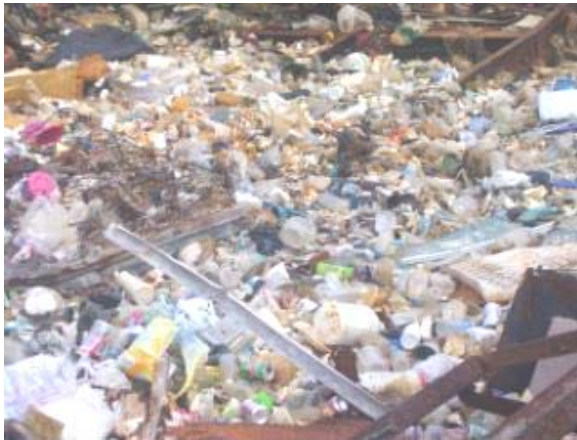
**Figure 5.11 - Plastic bottles and containers in trash**

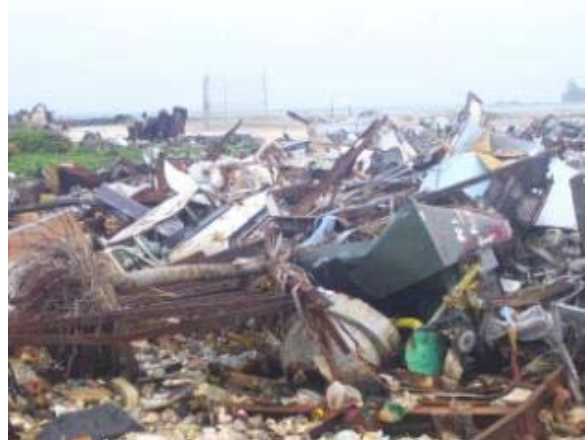
**Figure 5.12 - Metals mixed in the trash**

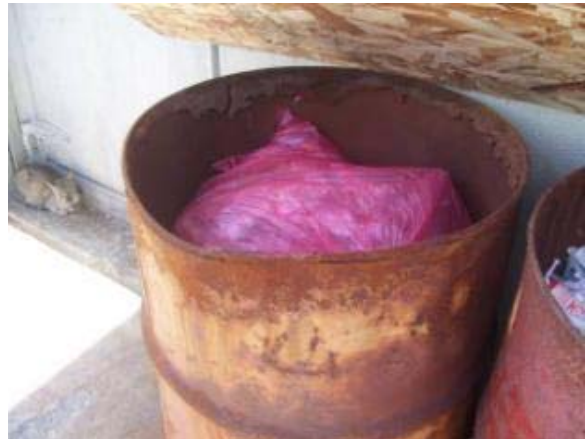
**Figure 5.14 - Red bag medical waste**

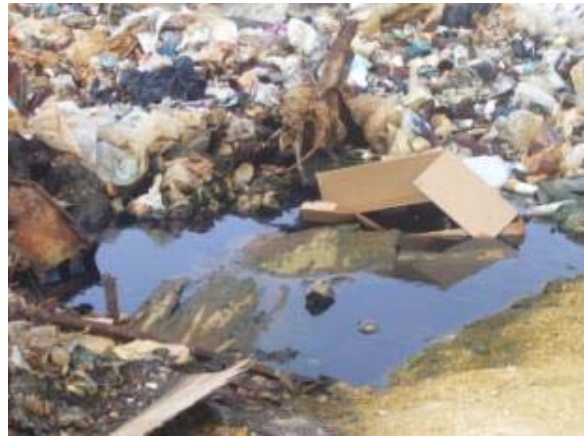
2. The dumpsite is not secured and access is not controlled. Most of the perimeter is not fenced. There were several children observed playing at the dump during the survey (Figure 5.25), and some of them were close to the burning trash (Figure 5.26). Children playing at the dump risk exposure to hazardous material, medical waste, vectors, sharp objects, and toxic fumes from the burning trash (i.e. dioxins, toxic industrial chemicals/materials, etc).

**Figure 5.19 - Leachate formation**

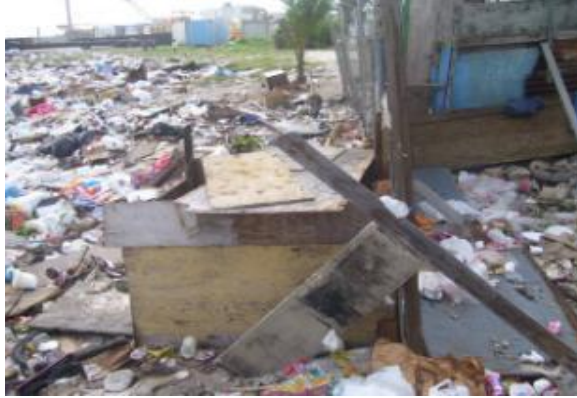
**Figure 5.22 - Trash piles in residential backyards**

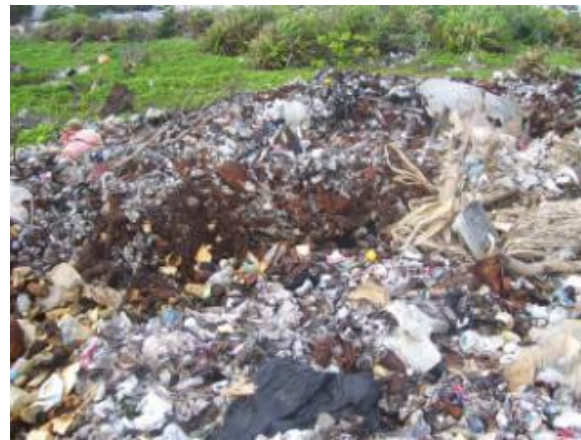
**Figure 5.24 - Partially burned trash pile**
