*Archaeological Reconnaissance Survey of
Bikej Island, Kwajalein Atoll:
A Preliminary Survey Conducted by the Historic Preservation Office
for the Environmental Protection Authority*

HPO Report 1999/01

Archaeological Reconnaissance Survey of Bikej Island, Kwajalein Atoll

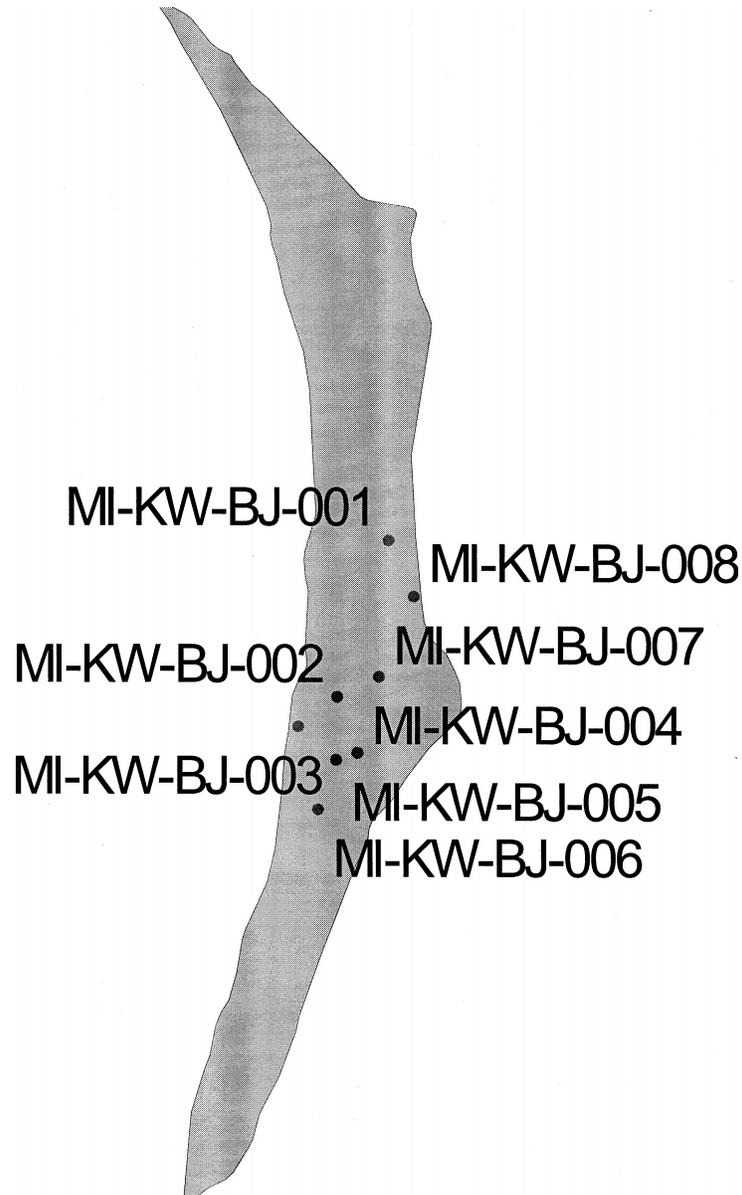
Map 1. Sites located on Bikej Island, Kwajalein Atoll, Marshall Islands.

A complete description of each site follows. See Map 1 for the location of each site.

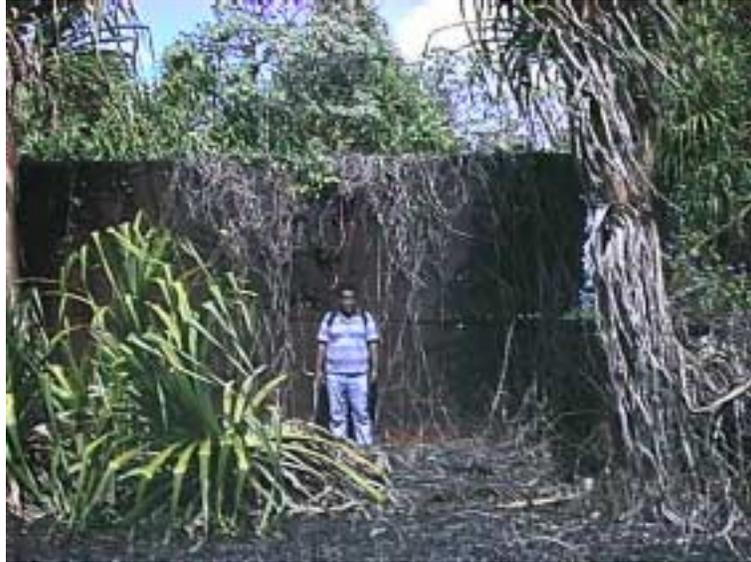
MI-KW-BJ-001 (Marshall Islands-Kwajalein Atoll-Bikej Island-Site No. 1)
Site number one on Bikej Island is Tank One. This is one of the larger tanks, measuring 30 meters in diameter. This tank's preservation is quite good with the walls of the tank surviving up to 4.5 meters in some places (Fig. 1).

Figure 1. Interior walls of Tank One.

It is recommended that archaeological monitoring be required during all stages of the clean up and that the HPO be included in all stages of clean up preparation. The reasons that monitoring is required is as follows:

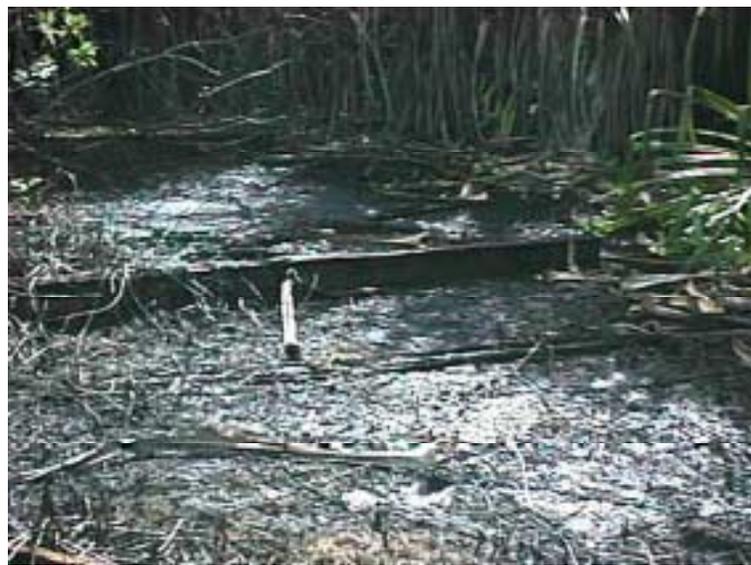
The surface within the tank can only be described as oily goo. It would appear that the porous nature of coral allowed for the oil to be absorbed by the coral and then almost liquefied the coral itself. While this action occurred within and around all the oil tanks, Tank One had by far the largest extent of oil leakage. Oil extends beyond the perimeter of the tank by approximately 100 meters. This site will be the most difficult to clean up by far. Below the surface, a metal floor was discovered. The condition of the floor is unknown, although it is assumed that it is completely rusted. On the surface, within the oil tank is large amounts of small rusted metal, indicating that the tank once had a metal ceiling. This is further posited by the extensive cross beams that supported the ceiling that litter the interior of the tank (Fig. 2). The remarkable condition of the tank classifies it as archaeologically very significant.

Figure 2. Cross Beams of Tank One.

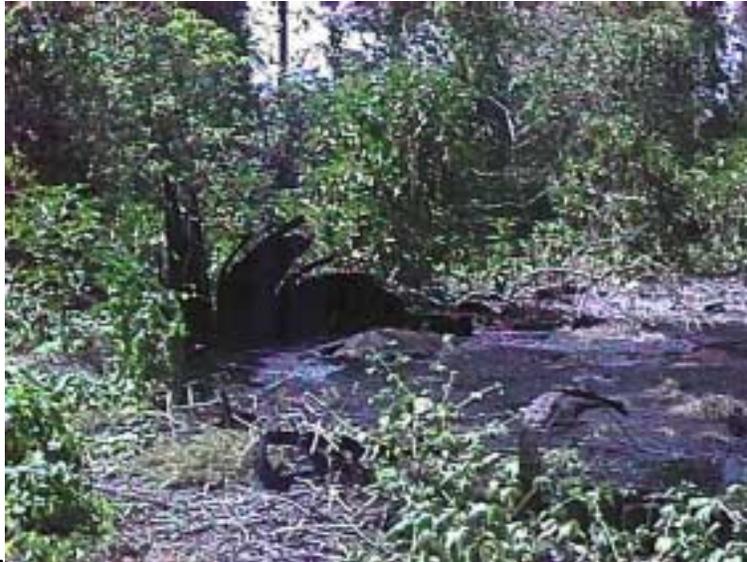
Tank 2. Tank 2 is the smallest tank with a diameter of 5m. The preservation of the tank is not remarkable (Fig. 3). This tank also contains the thickest and most concentrated remains of oil. (Fig. 3). The oil slick covers the entire surface of the tank and measures 15 cm deep. At that point the remains of floor was probed. The walls are almost completely destroyed, but there are remnants of steel beams that indicate a ceiling. The preservation of this tank in conjunction with the other tanks makes this site archaeologically significant.

Figure 3. Tank Two

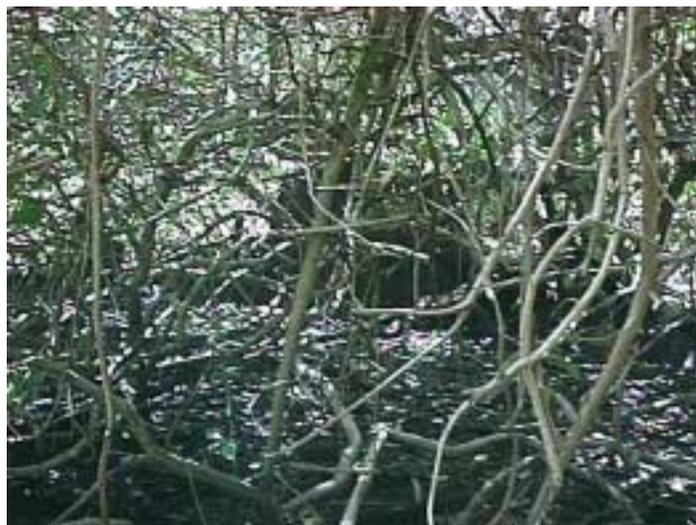
Tank 3. Tank 3 has a diameter of 15 meters. It has less oil and more vegetation growing inside (Fig 4). The oil seems self-contained. The preservation of this tank is also quite

Figure 4. Tank Three

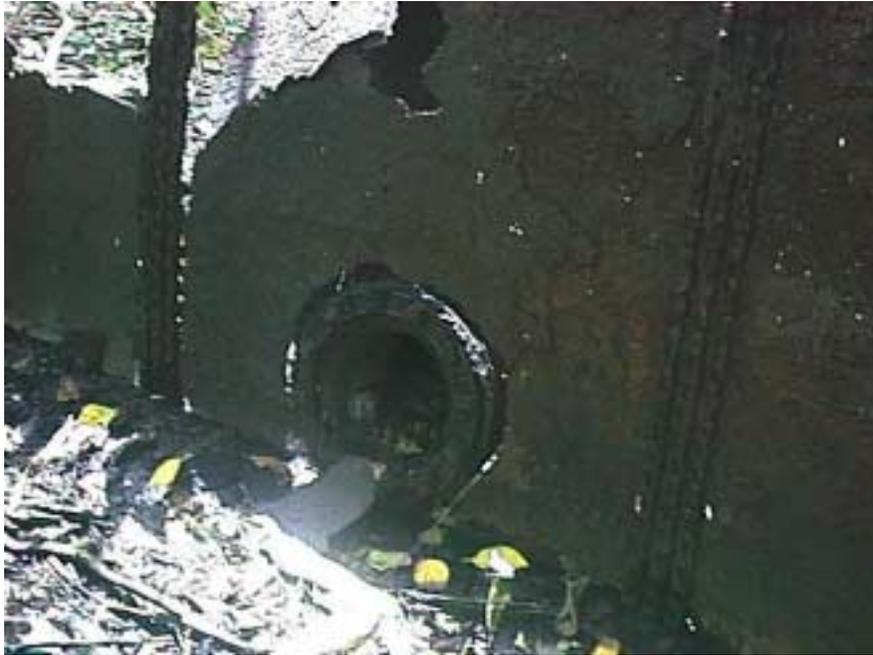
poor. This tank does have a well-preserved pipeline connected into the tank (Fig 5). The pipeline continues for several meters outside the tank (Fig 6). This site is considered archaeologically very significant.

Figure 5. Tank Three's Connection to a Pipeline

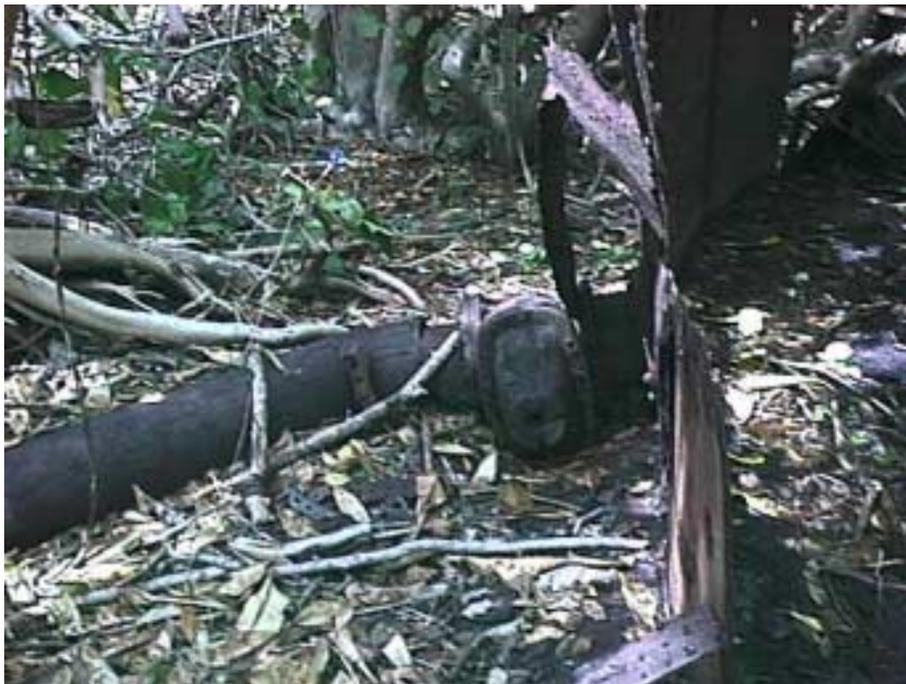
Figure 6. Pipeline Running Outside of Tank 3.
