# ***Ebeye 2010 Infrastructure Survey Report***

565<sup>th</sup> EN DET (FEST-A)

15 June 2010

**SUBJECT: Ebeye Infrastructure Reconnaissance Report Closure Memorandum**

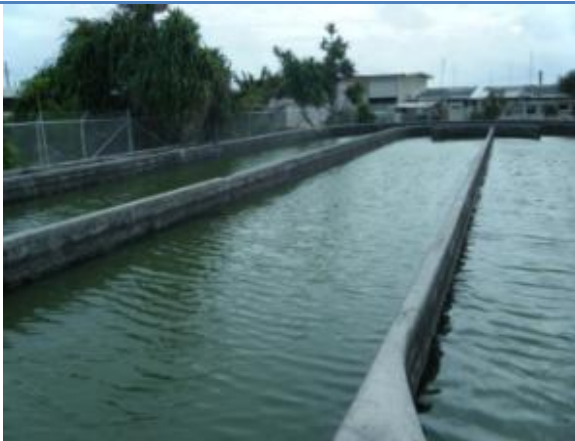
Figure 2.2 - Oxidation ditch “racetrack”

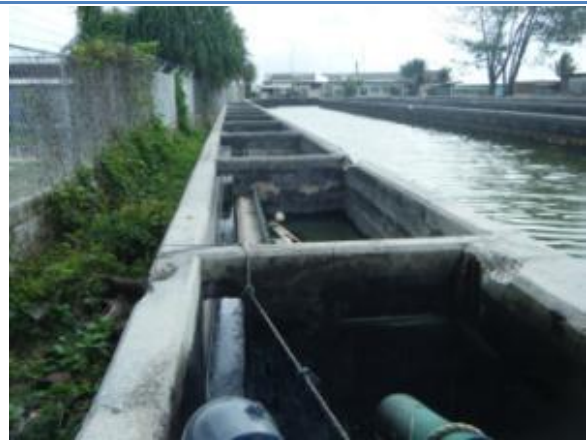
Figure 2.3 - V-notch weir and effluent box

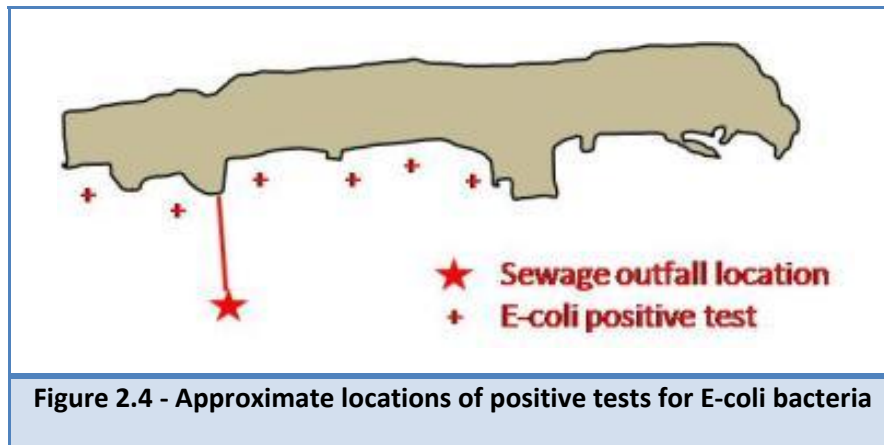
1. The sewage treatment plant was not in operation and has not been operated for a while. Interview of personnel, shows that the plant has not been operated in 5 years. Raw sewage

has been directly sent to the outfall in the lagoon. Republic of Marshall Islands EPA shows the presence of E-coli bacteria on the lagoon side of the island. The outfall is located approximately 500 feet offshore on the lagoon side of the island (Figure 2.4).

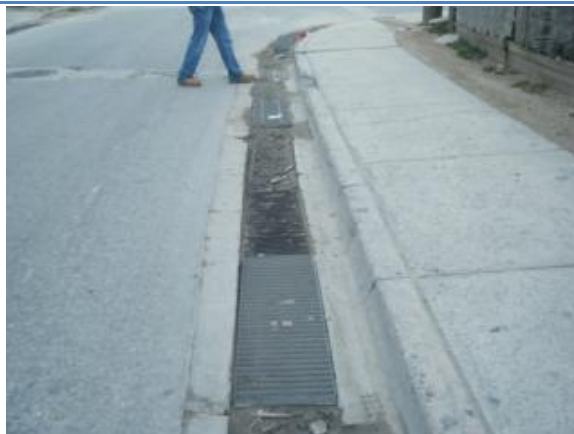
1. The inspected drywells on the island were clogged with dirt and no longer functioning (Figures 2.14 and 2.15). Additionally, most of the trench drains on Ebeye are also filled with debris and sand (Figures 2.16 and 2.17). These drainage structures cannot function if filled with sand. The sand made it impossible to inspect these drainage structures for physical defects. It is assumed most of these drainage structures are in good shape.

**Figure 2.16 - Dirt can be seen up to the top of the grill on these trench drains**

1. Clear the existing drainage structures of sand and debris to bring to an operational status.
2. Survey and repair dilapidated outfalls and associated piping.

5. Develop a maintenance plan to keep existing drainage structures clear of sand and debris. The maintenance plan needs to be developed by personnel that have historical observation of clogged areas. It is recommended that the plan be developed by “in-house” personnel familiar with the drainage issues.

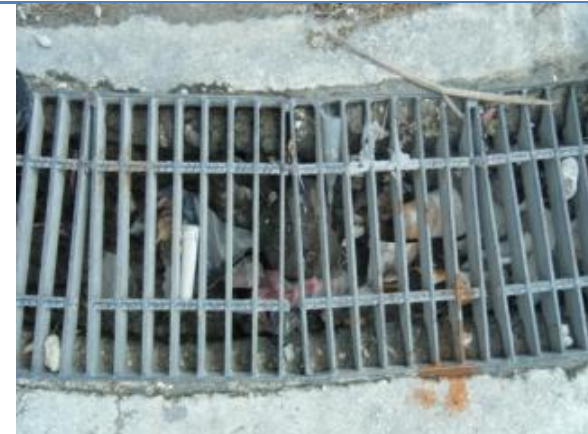
**Figure 2.17 - Most trench drains were filled with either dirt or debris**

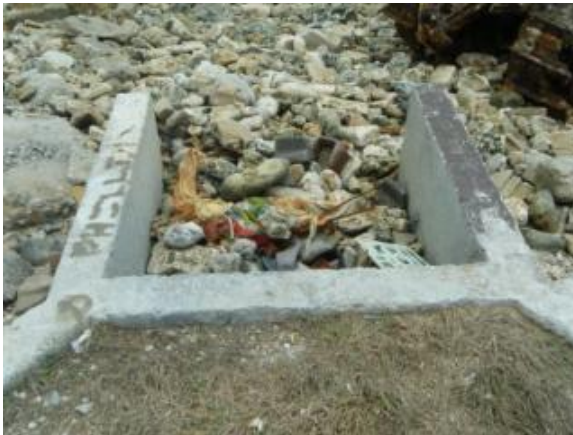
2. Storm manholes on the island either drained to an outfall or drywell. Structures draining to drywells were ineffective. The manholes draining to outfalls functioned better as some outfalls were still operational. Outfalls that were no longer functioning were: clogged,

missing, or need repair. Some have suffered from the effects of erosion; Figures 2.18, 2.19, 2.20 and 2.21 are examples of some of the conditions.

**Figure 2.20 - Outlet headwall filled with debris**

- a. Outfalls that are exposed and damaged due to erosion.
  - b. Outfalls that are clogged with sand and debris.
3. Recommend a topographic survey be conducted so a watershed analysis and storm water design can be conducted and managed. Without a topographical survey it is impossible to design a proper system for conveyance of water.

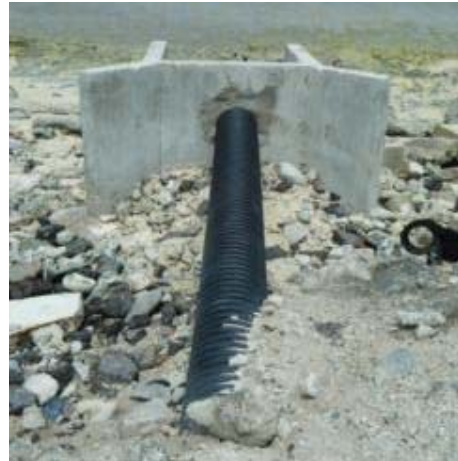
**Figure 2.21 - Outfall exposed due to erosion**

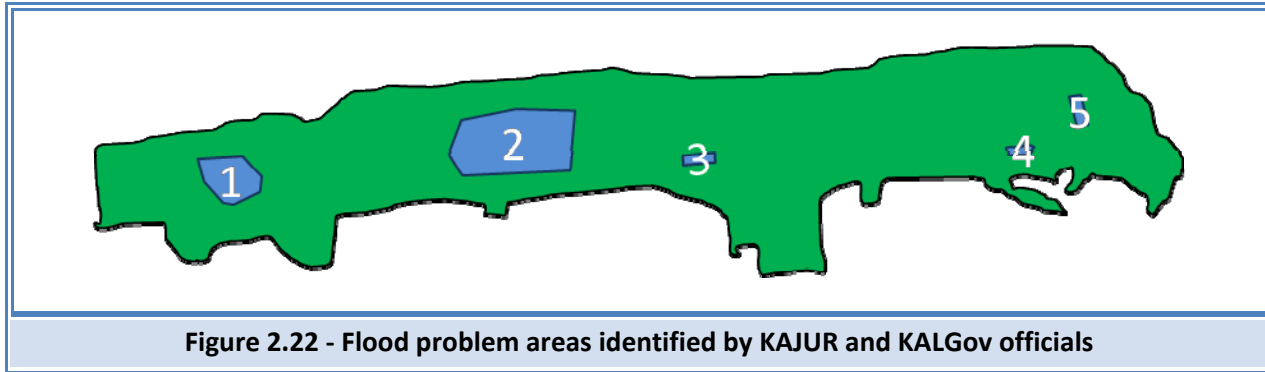
- There were areas identified by KAJUR and KALGOV officials as flood problems areas. Identified flood problem areas are depicted in Figure 2.22. The results of the findings in these flood areas are identified in Table 2.2.

AREA	AREA, ACRES	FLOW, *Q(CFS)	FINDING
1	1.2	3.1	This unpaved area has no drainage structure.
2	2.9	7.6	Flooding of homes regularly occurs degrading the quality of life for this neighborhood. A drainage structure has been installed, but is inadequately sized for the area and is clogged.
3	0.038	.30	This paved area is just off the pier by Triple J store, the largest store on the island. There is an existing drainage structure in the area, but it easily clogs with sand. Recently the owner of Triple J had the outfall snaked which seemed to clear up the problem. However, this fix is only temporary as it quickly fills with debris and sand.
4	0.081	.64	This paved area is north of the RMI office and in front of a residence. It is in the bend where the perimeter road starts to head north from the south. There is an existing drainage structure in the area, but it easily clogs with sand.
5	0.044	.35	This is the paved road behind the RMI office. There is an existing drainage structure in the area, but it easily clogs with sand.

4. Design and build a storm drain infrastructure for areas 1 and 2 (Figure 2.2) identified by KAJUR. Area 2 should have a higher priority since there are more people living in that area.

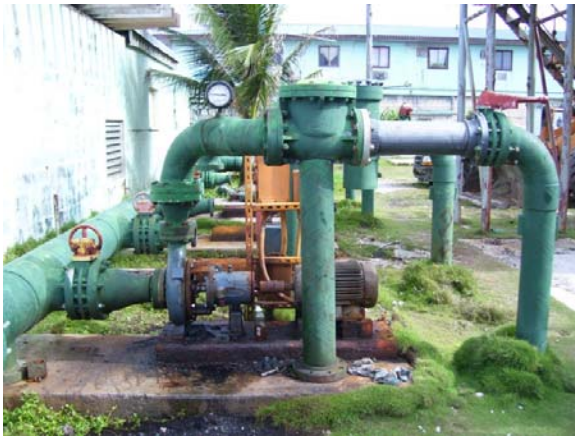
- b. Pressure for SW system is provided solely by existing pumps located at the South and North Wells. These pumps do not adequately pressurize the SW loop (Figure 3.6 and Figure 3.7 are photos of Well Pumps 1 and 2).

**Figure 3.6 - Well Pump 1 (South)**

- a. Well 1 (South). The eight year old 20 HP, 250 gpm pump shown in Figure 3.6 above, is mounted on an exterior pad, is exposed to the elements, and showing signs of corrosion, but appears to be in fair condition (no adverse noises, leaks, vibration, etc). There are no back-up pumps, working pressure gauges, spare parts, or back-up power at the well site.
- b. Well 2 (North). The 450 gpm pump shown in Figure 3.7 above, is protected from the elements by a pump house. The age of the pump and motor are unknown, are showing signs of corrosion, but are working well (no adverse noises, leaks, vibration, etc). There are no back-up pumps, spare parts, or working pressure gauges on site. The emergency generator was taken out of service more than 5 years ago. The generator room is currently being used for storage.

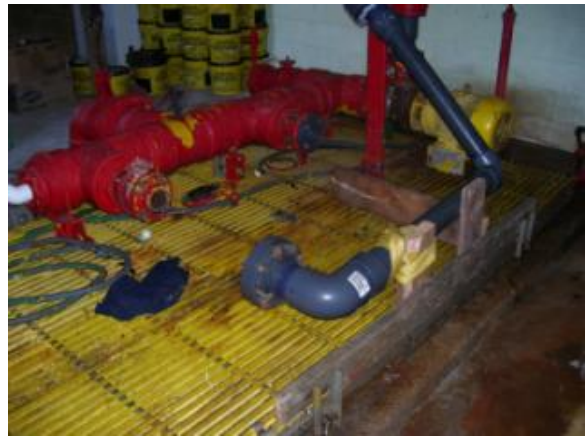
**Figure 3.7 - Well Pump 2 (North)**

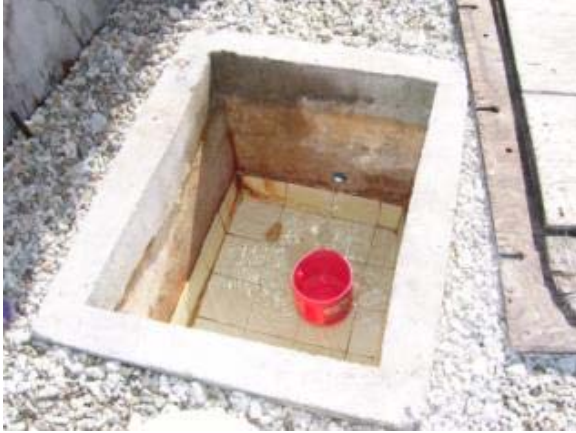
5. FW distribution system pressure is insufficient. Residents further away from the WTP lack sufficient pressure to support interior fixtures. Due to low pressure in their homes, residents are tapping into service lines and creating in-ground basins to gain access to water (Figures 3.8 and 3.9). KAJUR officials indicate this is a common practice. This practice further exacerbates the low pressure problem. Reasons for low pressure include:
  - a. No elevated tanks.
  - b. Existing pumps are inadequate to supply sufficient pressure for the FW loop.
  - c. No pressure regulating valves (PRV) to control water pressure at the point of delivery.

**Figure 3.8 - Example of in-ground basin**

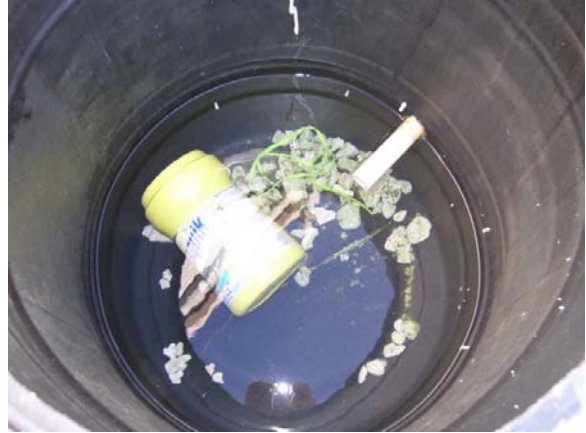
**Figure 3.9 - Example of in-ground basin**

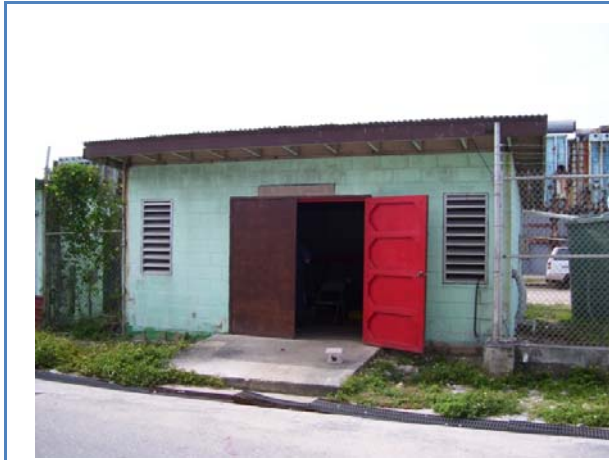
- a. There are two SW and three FW pump houses. The pump houses are in good condition. The buildings are structurally sound, and roofs do not leak.
- b. The WTP building is in good condition. It is structurally sound, and roof does not leak.

**Figure 3.11 – SW Pump House 1  
(typical)**

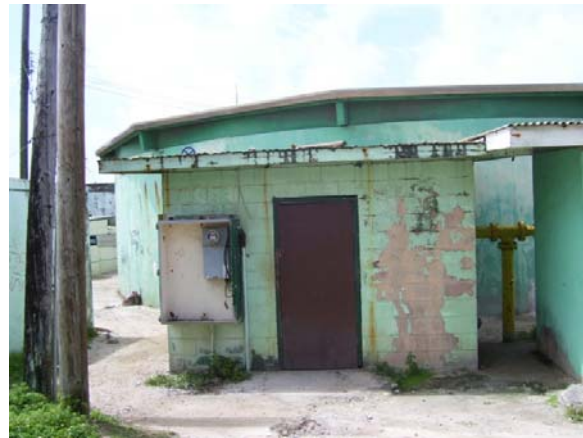
**Figure 3.12 – FW Booster Pump House  
Central (typical)**

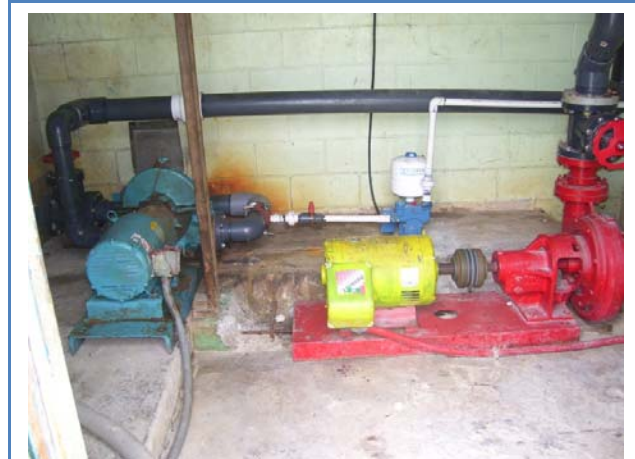
- c. FW Booster pumps. A 500 gpm main booster pump located in a pump house at the WTP pressurizes the water distribution system. The pump is in good condition (no corrosion, leakage, adverse noises, vibration, etc). A 130 gpm booster pump is used as a back-up for the main booster pump (Figure 3.13). During our visit the back-up pump was under repair. There is no back-up power and no spare parts were available for the booster pumps.

**Figure 3.13 – FW Booster Pumps**

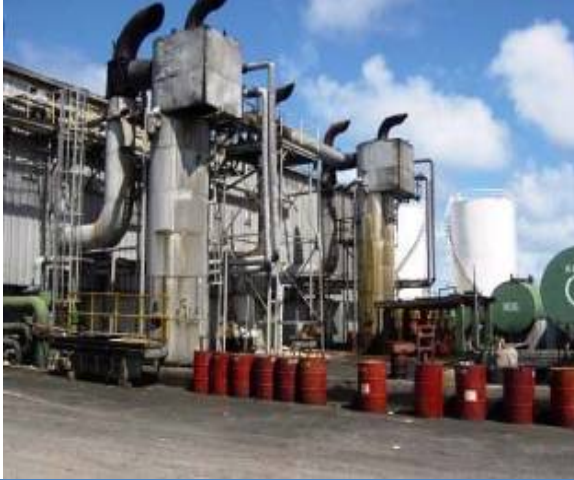
Overall, the condition of the generation plant is rated AMBER. The power plant has sufficient capacity for present and future growth. However, major scheduled maintenance of engine generators cannot be performed because the stand-by unit cannot be completely shutdown. Also, the switchgear and its associated equipment are 30 years old and replacement components are unavailable.

Figure 4.2A – West View of Power Plant

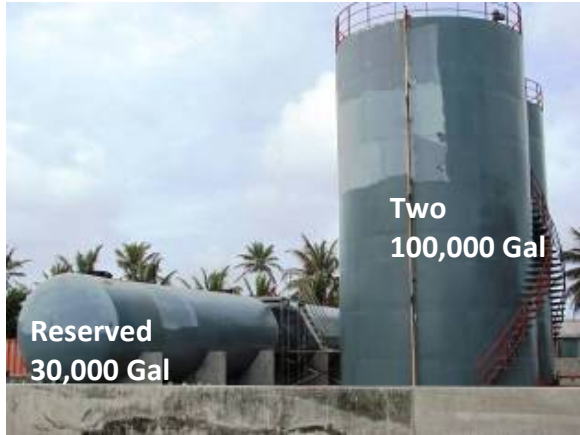
Figure 4.3 - Diesel Storage Tanks

Diesel fuel is transported by ship from Majuro to Ebeye and stored in two identical 100,000 gallon tanks. Fuel is then pumped into the plant via a settling tank to reduce the moisture content. The plant consumes 2,900 gallons of fuel per day to generate a total of 43,000 kWh. The diesel tanks are shown in Figure 4.3.

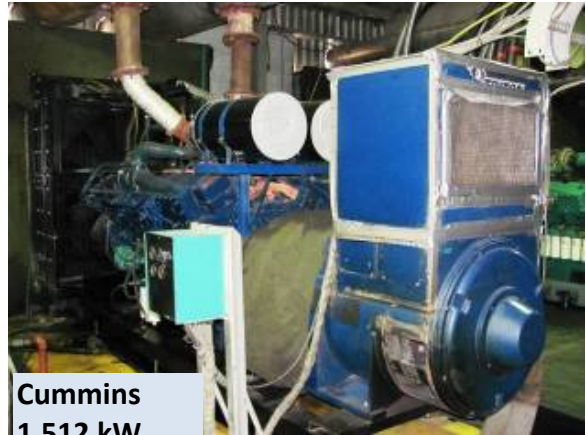
The three diesel generators are designed for load sharing operation and can be run in parallel. Normally, units #2 and #4 are operated continuously to power the loads while unit #3 is in stand-by. At the time of visit, unit #3 had a leaking radiator which prevents it from operating continuously for more than 48 hrs due to overheating. Replacement of the radiator is scheduled, pending receipt of additional materials which are on order. Key specifications for the diesel generators are listed below (Table 4.1). Figure 4.5 through Figure 4.8 show the engine room as well as each individual diesel engine generator.

Figure 4.6 - Engine Generator #3

5. Execute project to replace radiator and fan. During our survey, engine #3 had a leaking radiator and could not be run continuously for more than 48 hrs without overheating (Figure 4.28). KAJUR is aware of this problem and has taken measures to repair the radiator. Materials are currently on order. Normally, engine #3 is in standby for use in the event one of the main generators must be taken off line for emergency repair. However, with a leaking radiator, engine #3 will not be able to meet demand should one of operating generators experience a major failure.

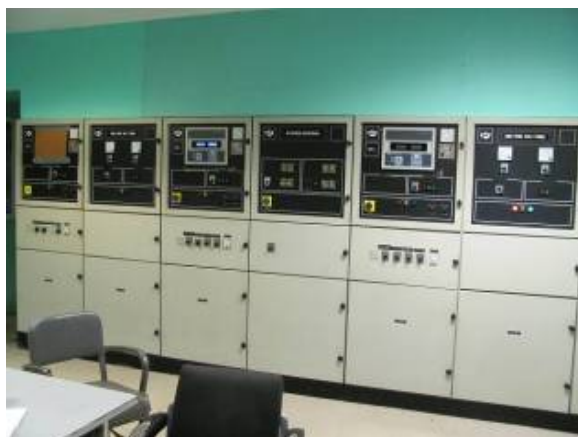
**Figure 4.12 - Generator Switchgear**

4. Obsolete switchgear in the generation plant. The power plant switchgear needs to be programmed for replacement. It has operated beyond a reasonable service life. Furthermore, the switchgear has not received any maintenance in over 10 years. The ability of this switchgear to operate safely cannot be established without this periodic maintenance. Even with maintenance, the switchgear ability to safely interrupt a fault is indeterminate because it is too old. The existing electrical distribution system might last another ten years or it might fail this year.

3. Upgrade the switchgear and associated equipment in the power plant. The switchgear and its associated equipment in the power plant are 30-years old and replacement components are unavailable. All distribution feeders passed through this equipment. Should the system fail, half of the island will be without power for a prolonged period. The top concern is that the over-current protective relay of the main breaker of the feeder bus is no longer in operation and cannot be repaired. The role of a protective relay is to actuate the breaker to isolate a fault. Without a protective relay, the breaker will not trip should a short circuit occur on one of the downstream feeders.

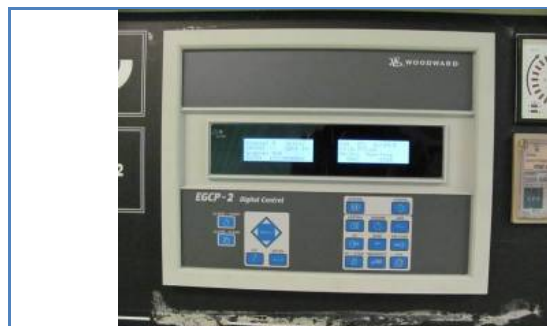
**Figure 4.7 - Typical Generator Relay Panel**

Power plant equipment is protected by a typical plant protection scheme, including over-current, over-voltage, under-voltage, differential, frequency, synch-check, and power relays. The protective relays are solid state units. There were no records of relay calibration. Typical relay control panels are shown in Figure 4.16 and Figure 4.17.

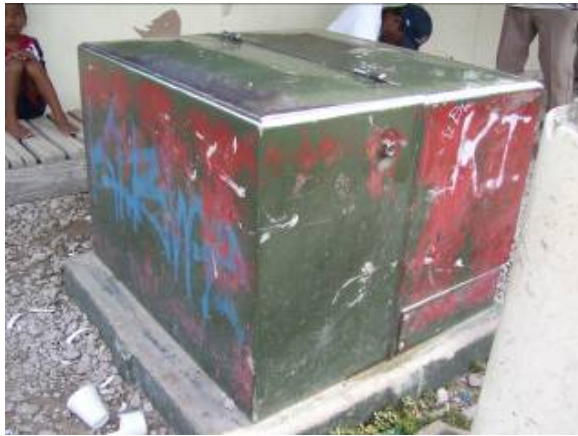
Figure 4.23 – Typical pad-mounted transformer

7. Distribution transformers operated within rated capacity. Most transformers are loaded to less than 40 percent of their rated kVA, even during periods of peak demand. All the pad-mounted transformers were installed in 2002. At eight years old, the condition is still fairly good. The stainless steel cabinets do not exhibit any rust, leaking, or deterioration.

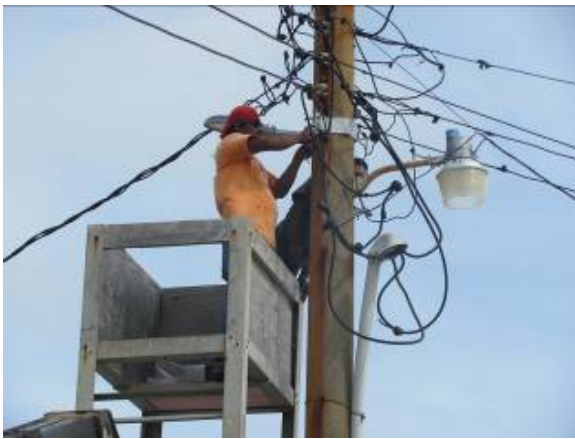
8. Continue the outstanding in-house improvement program. In recent years, KAJUR electricians have completed several in-house upgrades to the distribution system. Projects such as the installation of a new isolation switch and replacement of pole hardware on the Gugeegue overhead line have greatly improved the reliability and safety of the distribution systems (Figure 4.27). In the past, due to lack of system coordination, faults occurred on the 13.8 kV overhead line have caused nuisance tripping of the generators at the power plant. The new switch has effectively isolated the faults with minimum disruption of power to the rest of the system. Other upgrades such as replacement of old and inefficient high-pressure sodium street lights with LED fixtures have reduced system loss substantially (Figure 4.26).

**Figure 4.9 – Upgrade Street Light to LED Fixture**

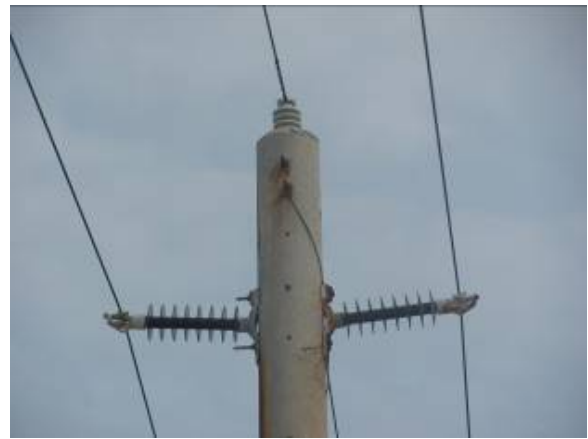
**Figure 4.10 – Replace Pole Hardware Project**

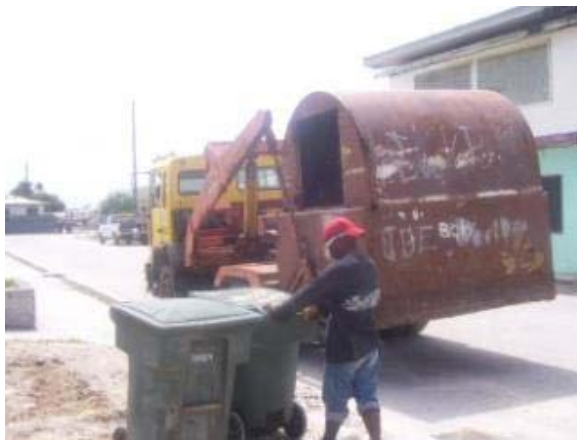
Figure 5.1 - Trash collection crews

Trash is collected by two municipal crews from 8:00 a.m. to 5:00 p.m., Monday through Sunday. The equipment utilized for this process consists of an 11 cubic yard trash compactor truck with a rear hydraulic loader and a five ton truck with a six cubic yard dumpster attachment (Figures 5.1 & 5.2)

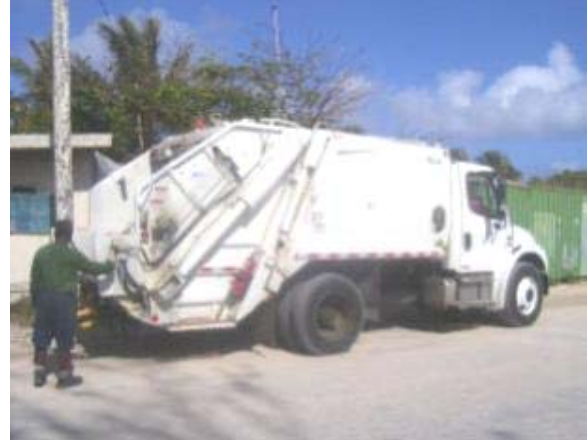
Figure 5.2 - Trash compactor truck, 11 CY capacity

1. Purchase another trash compactor truck. This will provide backup in the event one truck breaks down and insure that the collection service is not interrupted. An additional collection truck will significantly reduce the amount of time and manpower needed to collect the trash.
2. Purchase 160 replacement trash bins. Include repair parts such as lids, hinges, and wheels. Repair and replace containers as needed. Another option is to purchase communal steel dumpsters which would reduce the amount of collection points and maintenance required.

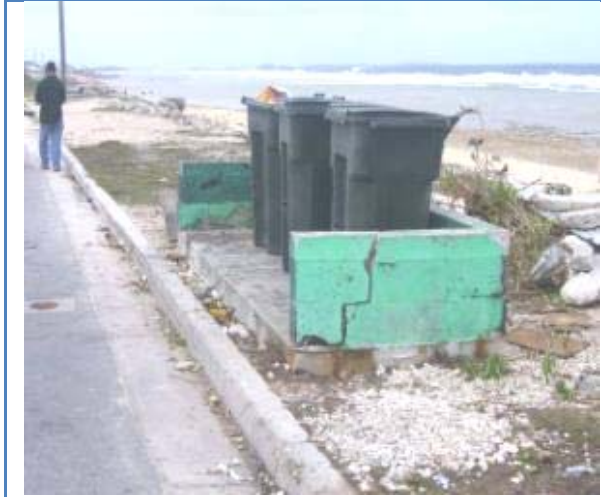
**Figure 5.3 - Typical trash bin setup**

the dump twice each day. Figure 5.3 shows a typical roadside trash bin setup.

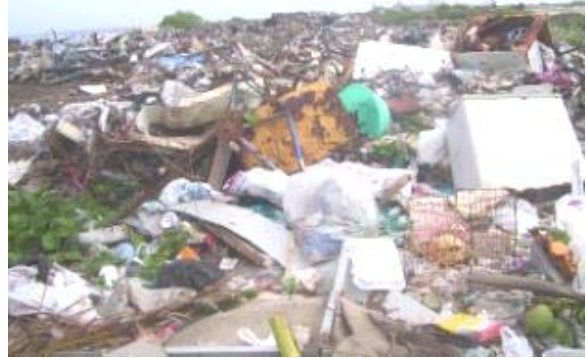
The dump is located at the northern end of the island and occupies an area of approximately 5.3 acres (Figure 5.12). The facility is an open area where all the trash is dumped and eventually burned. There are no burial cells or trenches at the site and no compaction or fill is done. Currently, there are randomly spaced trash piles at the center of the site that occupy an area of approximately 3 acres (Figure 5.13), and along the west end, there is an area of approximately one acre used for discarded vehicles (Figure 5.14).

Figure 5.8 - Dumping area at center of dump

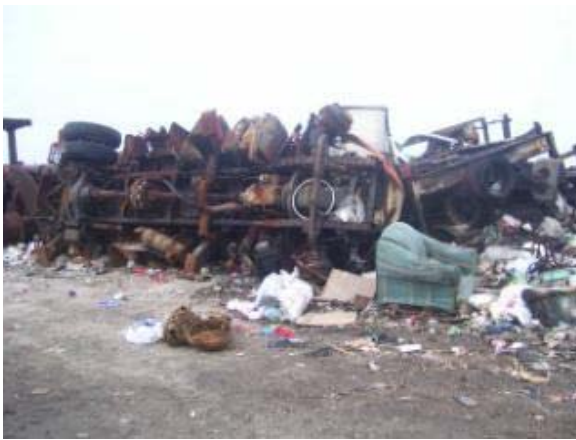
Figure 5.9 – Discarded vehicles west end of dump

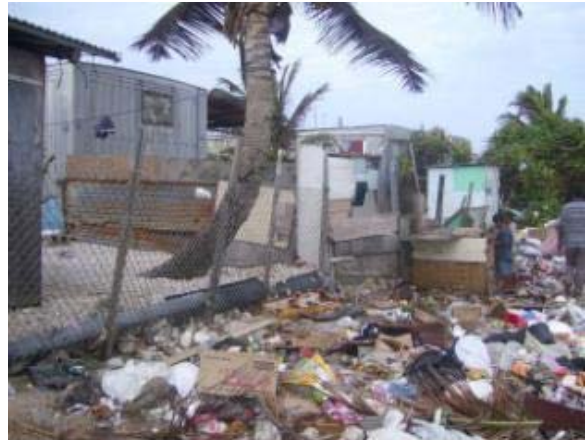
Figure 5.10 - Residential area adjacent to dump

The southern section borders a residential area (Figure 5.15). There are approximately 1.3 acres on the northern end which are clear of trash and currently used as a baseball field. Most of the dump is not fenced. The site is not secured and access is not controlled.

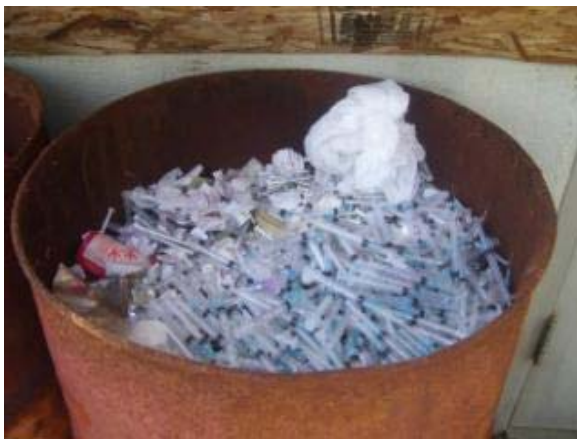
**Figure 5.13 - Sharps**

sharps, red bag waste, expired medicines and pharmaceuticals (Figure 5.18 & 5.19) and hazardous waste such as oil/fuel filters, paints, used oil, household chemicals and assorted batteries. A waste analysis survey with the quantities generated per each waste stream was not available at the time of the survey.

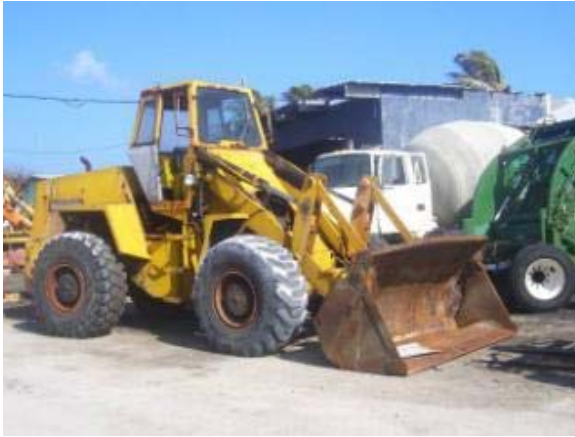
**Figure 5.15 - Front end loader**

The equipment available for dumpsite operations had visible signs of deterioration and rust. However, the DPW stated that the equipment was functional. The equipment is as follows:

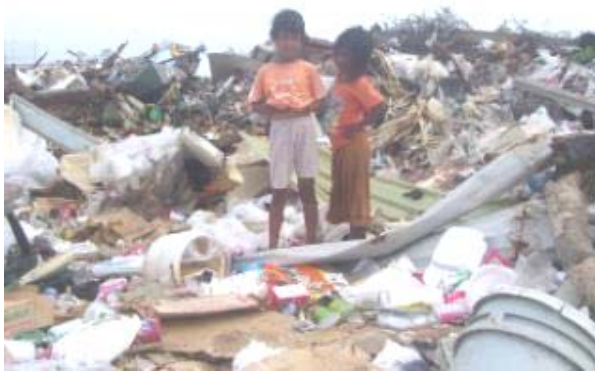
2. The dumpsite is not secured and access is not controlled. Most of the perimeter is not fenced. There were several children observed playing at the dump during the survey (Figure 5.25), and some of them were close to the burning trash (Figure 5.26). Children playing at the dump risk exposure to hazardous material, medical waste, vectors, sharp objects, and toxic fumes from the burning trash (i.e. dioxins, toxic industrial chemicals/materials, etc).

**Figure 5.20 - Unsecure dump site**

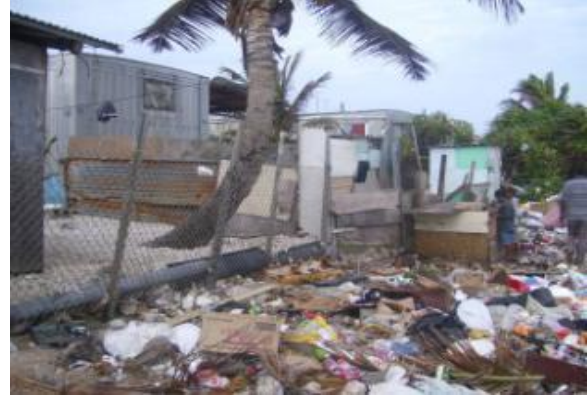
**Figure 5.23 - Housing adjacent to dump**

3. Move the trash piles away from the homes. The conditions for residents on the southern border of the dump can be improved significantly by moving the trash piles away from their homes and by maintaining a minimum setback distance. The vector infestation can be reduced and controlled by compacting and filling all existing trash piles. Remove as much of the larger pieces of metal in the trash piles prior to compaction and fill. The DPW has a crane that can be utilized to harvest the sand needed for fill. However, a permit or approval from the RMI EPA should be obtained prior to harvesting of sand. Furthermore, the compaction and fill must be done in accordance to RMI EPA guidelines and standards.

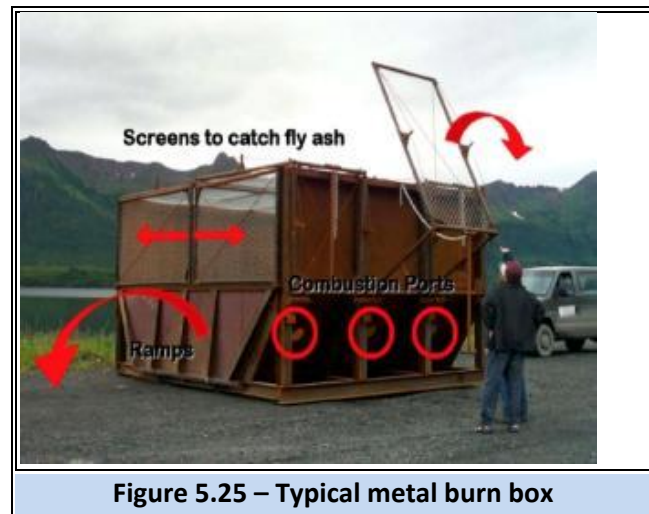
Figure 5.25 – Typical metal burn box

4. Install a burn box. The burn box does not require electricity or fuel and is easy to operate and empty (Figure 5.30). However, plastics and hazardous materials must be removed prior to burning to reduce the volume of toxic pollutants. This system provides a confined and controlled area which reduces the risk of spreading fires throughout the landfill while burning. Open burning requires approval from the RMI EPA (Solid Waste Regulations Part VI, 28(i)).
